## FIELD TESTING OF LED SIGNALS

### Introduction

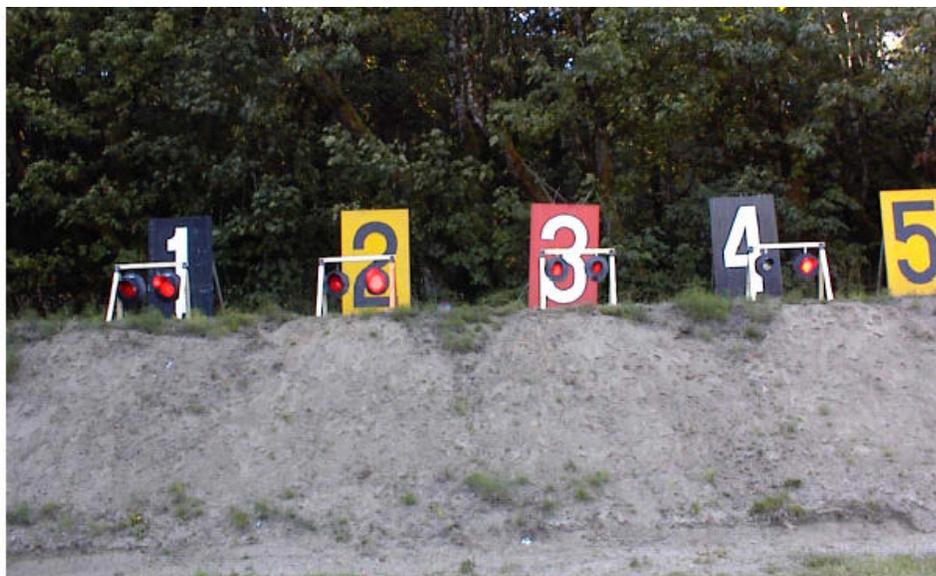
*Figure 85. Field testing set-up of signal lights (Green and Milanovic, 2002).*

In the laboratory environment, the light output of a signal is determined by measuring the luminous intensity and chromaticity; however, the visible range of a signal should ultimately be measured in a field testing environment. Green and Milanovic (2002) helped to develop the Transport Canada standard for highway/railway crossing signals in Canada. As a part of this study, field testing was done to compare the visibility of four pairs of LED signals and traditional incandescent signals. The intensities and beam patterns of the LED signals were first characterized in a laboratory environment. The luminous intensity of the four signals ranged from 300 to 800 candela. The field test was conducted at a former military firing range in Victoria, British Columbia. The signals were mounted to five sawhorses in front of the targets. The field testing set-up is shown in Figure 85. LED signals were placed in Lanes 1, 2, 4, and 5 and traditional incandescent signals were located in Lane 3. A focus group of eleven individuals evaluated the five pairs of signals simultaneously on a clear day. The signals were ranked on a scale of 0 to 10. A 10 was given to the most conspicuous signal, and the remaining signals were ranked in comparison to this signal. The group evaluated the signals at several observation points located between 50 yards and 1000 yards away from the signals. The test was repeated at night with only six evaluators. All four LED signals performed better than the traditional incandescent signals; however, the improved performance was less evident at night. Two more field tests were conducted using newer incandescent lamps and improved test stands. These tests also showed that LED signals performed better than traditional incandescent signals.

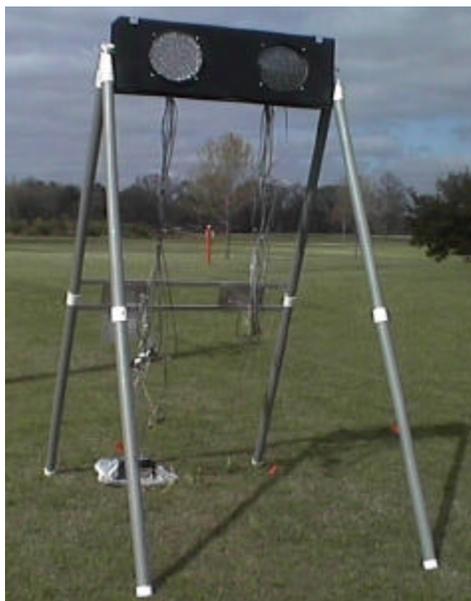
Two stands, shown in Figure 86, were constructed to encase two LED signals eight feet high. A manually operated switch system was designed and built to create different failure patterns. The stands also used their own power source (12 volt battery) to operate the lights.

*Figure 86. Signal housing with stand.*
